**MEANS BROOK
RESERVOIR DAM
CT 00092**

**PHASE 1 INSPECTION REPORT
NATIONAL DAM INSPECTION PROGRAM**

**DEPARTMENT OF THE ARMY
NEW ENGLAND DIVISION, CORPS OF ENGINEERS
WALTHAM, MASS.**

APRIL, 1980

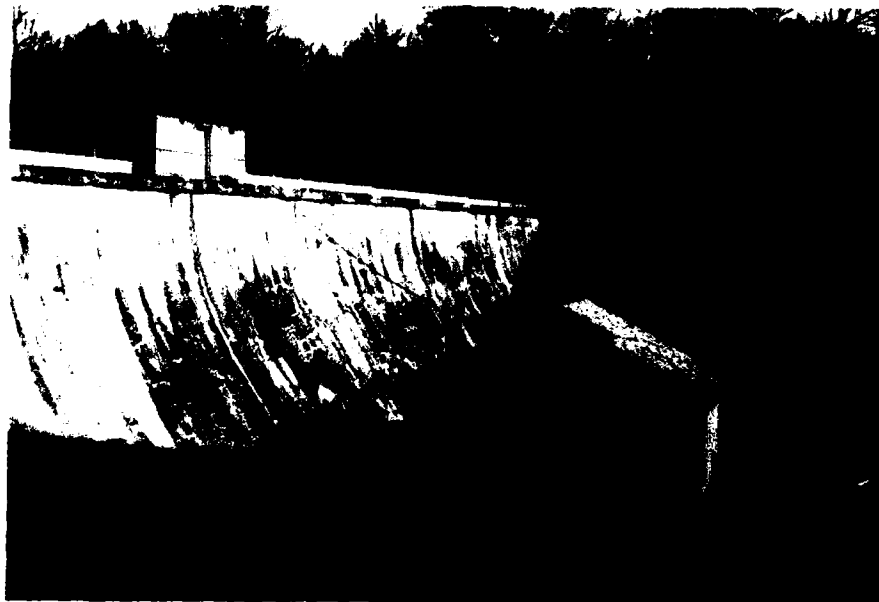
5. **Lower Gate House:** The lower gate house is a concrete structure in generally good condition (Photo C-2, building at toe of dam). Controls for the various gate valves are located in the house and appear operational. Pumps are also located in the house which may be utilized to increase the flow through the 36 inch pipe to the Trap Falls Reservoir.

C-2 DOWNSTREAM FACE OF DAM - LOOKING AT EAST
ABUTMENT

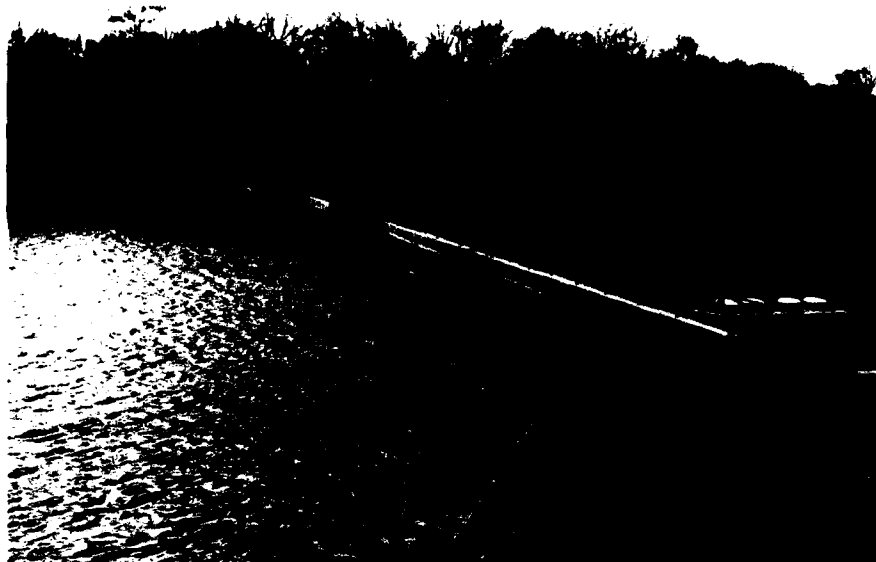
2. **Upstream face:** The upstream face of the dam is concrete with a vertical face (Photo C-3). The water level at the time of the inspection was 5.6 feet below the top of the dam (wall). Spalling and efflorescence was noted.
3. **Downstream face:** The downstream face is concrete with a sloped face (see record drawings in Appendix B). Substantial spalling and efflorescence was noted on the downstream face (Photos C-1, C-2). Leakage at the toe in the center of the dam was reported in a 1977 inspection. However, no sign of any leakage was noted in the inspection for this report.

C-3 UPSTREAM FACE OF DAM - LOOKING EAST

- a. An investigation as to the source and cause of the subsurface flow beneath the spillway.
- b. The upstream face of the dam be visually inspected.
- c. The spalling on the downstream face and the top of the dam be rehabilitated to their original condition.
- d. A further analysis be conducted as to the structural stability of the dam.

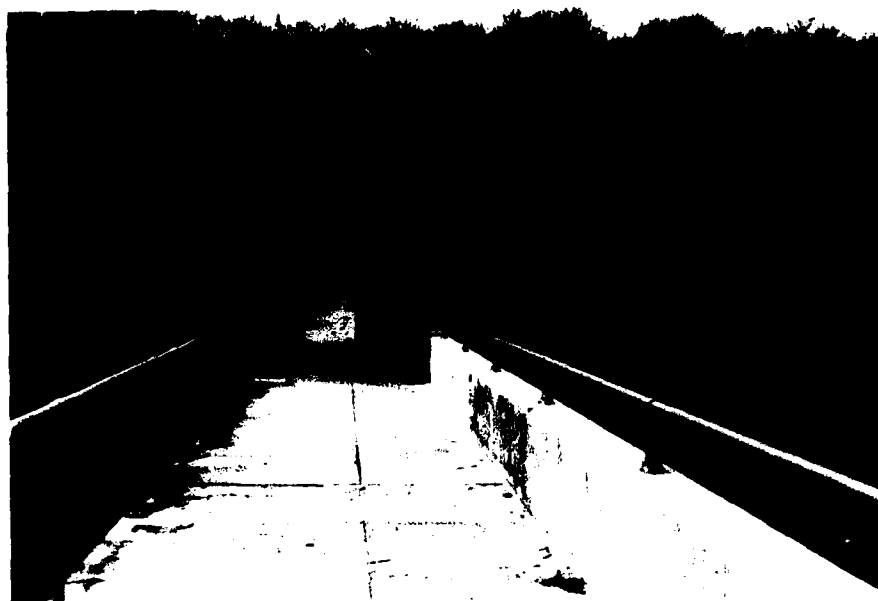
1. **Crest:** The top of the dam is concrete with no evidence of settlement or misalignment. The top is spalled (Photo C-4) and there is visible reinforcing in a few locations along the edge of the top (Photo C-5). A 2.1 foot high concrete wall was added to the upstream edge of the dam's crest in 1977 (Photo C-5).

The top of the dam has a width of 10 feet and support pipe railing (good condition) on both the upstream and downstream edges (Photo C-4).

4. **Upper Gate House:** The upper gate house is a concrete structure in generally good condition (Photo C-4). The lift mechanisms for the wet well intake sluice gates are located in the house and appear operational (Photo C-11).

C-4 TOP OF DAM SHOWING UPPER GATE HOUSE
AND 1977 WALL ADDITION

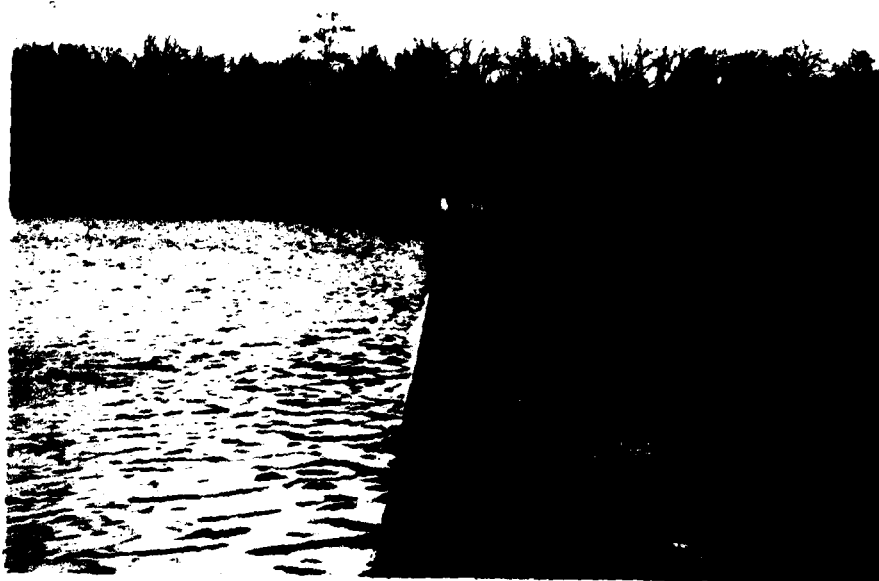
C-8 SPILLWAY - LOOKING EAST

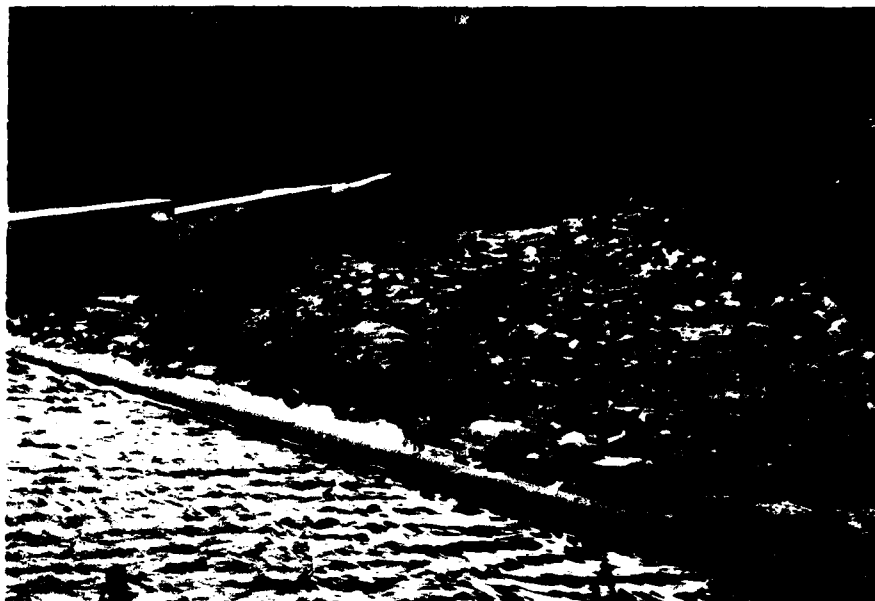
C-9 RACEWAY - LOOKING SOUTH

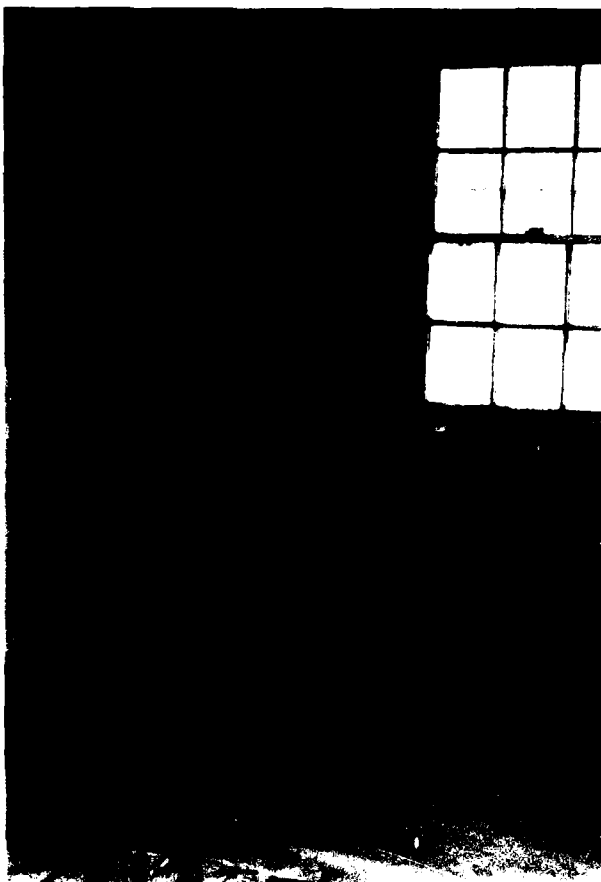
C-11 LIFT MECHANISMS INSIDE
UPPER GATE HOUSE
